SELECT STRUCTURAL

February 2, 2023

RE: Brick Wall Inspection
324 N. Main St.
Davenport, IA

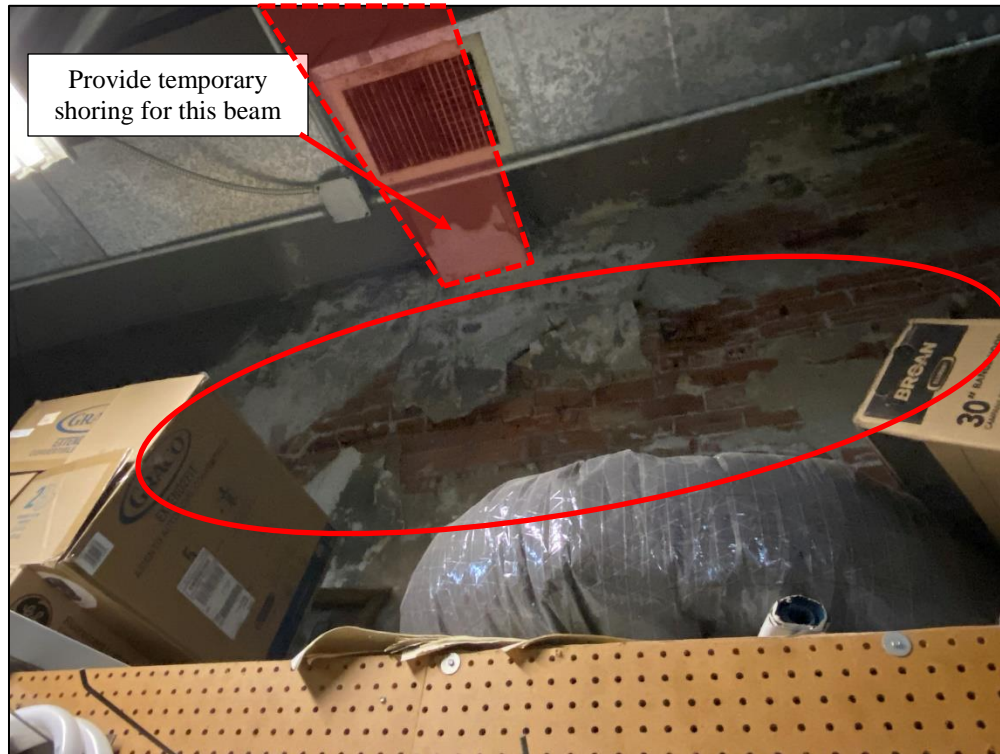
There is a storage and maintenance room on the west side of the building in which the damaged brick wall can be seen. The main area of brick damage is roughly eight feet wide by four feet high, and occurs directly below a beam which supports the second level. The beam is approximately 16 inches wide and is likely steel encased in concrete. It is unclear whether it bears on the brick wall directly or rather on a steel column encased in brick. Another, smaller, encased beam is parallel, roughly eight feet to the north. The bottom faces of the beams are roughly 15'-0" high. Both beams need to be shored with heavy posts so that permanent repairs can be applied. The permanent repairs will likely involve the replacement of the wall in this area. The on-site building maintenance team confirmed that the ductwork in this workspace along the west wall is abandoned and therefore may be removed. This will allow better access to the wall and beams above.

Photo 1 – Damaged Brick & Beam to Support

The main takeaway from the inspection is that this damaged area is not an imminent danger to the entire building and its residents. An evacuation or lockout of the building is not necessary at this time. The damage will still be addressed and repaired. The two beams mentioned shall be shored soon, out of an abundance of caution, but with this shoring in place the structure will be secure for the permanent, long-term repairs to take place. Another report detailing these repairs will follow at a later date.

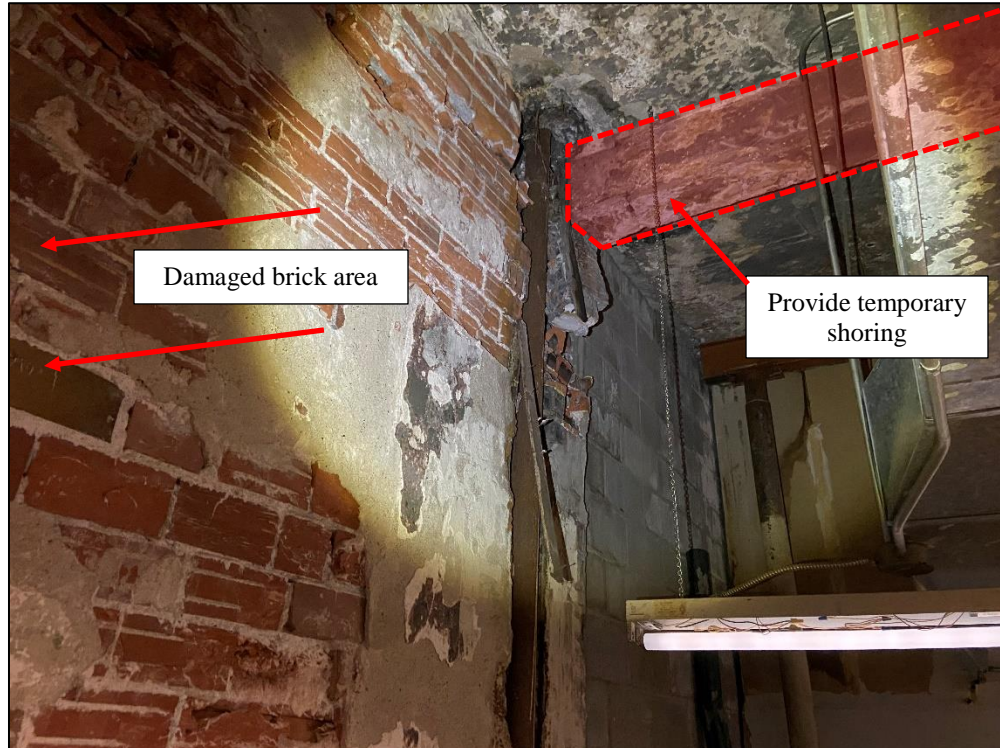
Photo 2 – Second Beam to Support
