# SELECT STRUCTURAL

February 28, 2023

RE: Brick Wall Repair – Addendum  
324 N. Main St.  
Davenport, IA

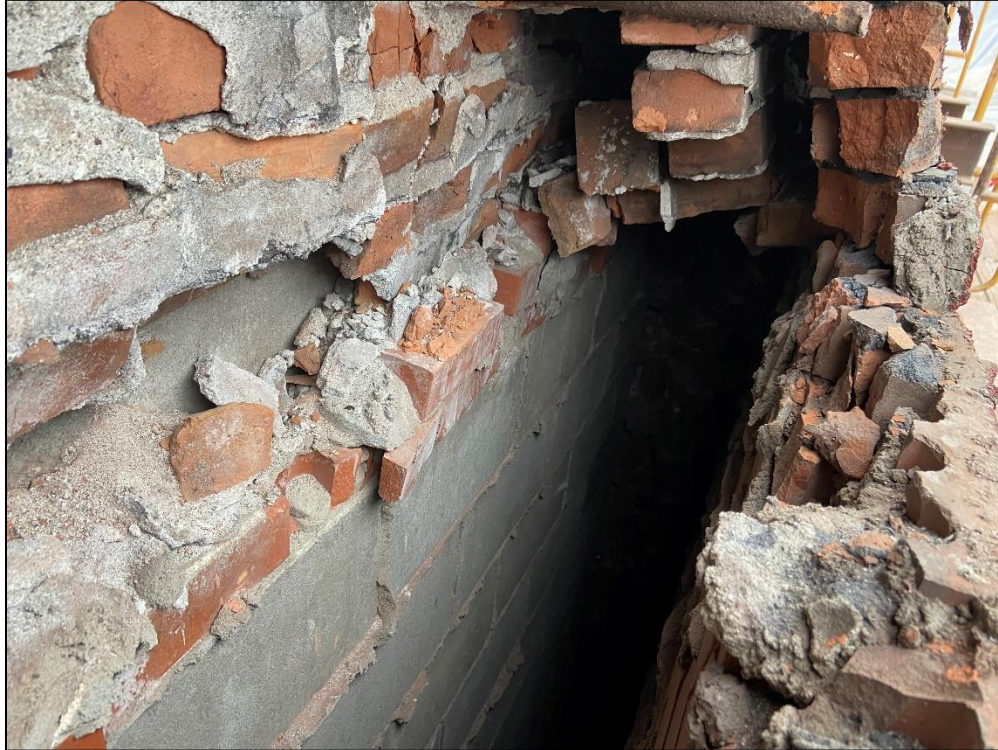
A follow-up site visit was performed at the property above on February 23<sup>rd</sup>. At the meeting, the mason pointed out that the area immediately to the north of the work area has a large and potentially dangerous void beneath the façade wythe of clay brick.

Photo 1 – Void between CMU and Clay Brick Façade

The Mason and Engineer agree that the most direct solution is to remove the brick façade in this area in a safe, controlled manner, and then to construct a second, outer layer of CMU from the ground level up to the top of the void (roughly 15 to 18 feet). This would allow the safe removal of unstable clay brick and add solid structure to the compromised wall. The repairs to the original twelve-foot-wide area of wall would proceed as it is now.

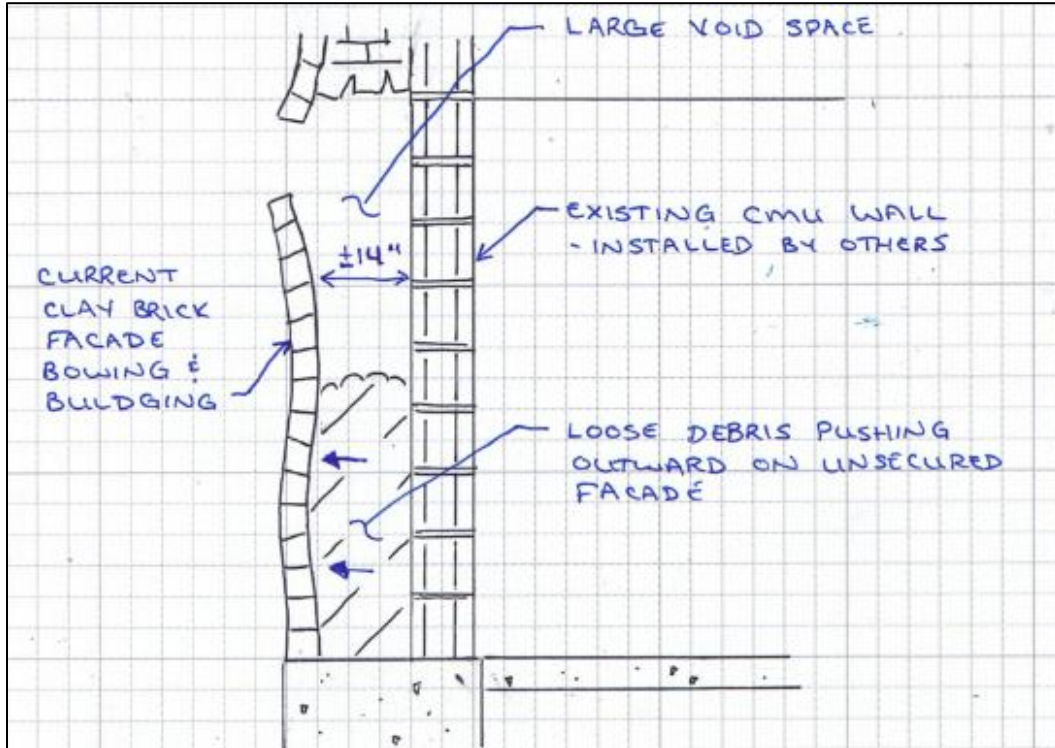
Figure 1 – Current Condition
